Superfund NEWS

EPA probes reveal need for additional repairs to Waste Pits Cap

Toxic material exposed after Hurricane; cap membrane missing

EPA Directs Additional Repairs for San Jacinto River Waste Pits Superfund Site

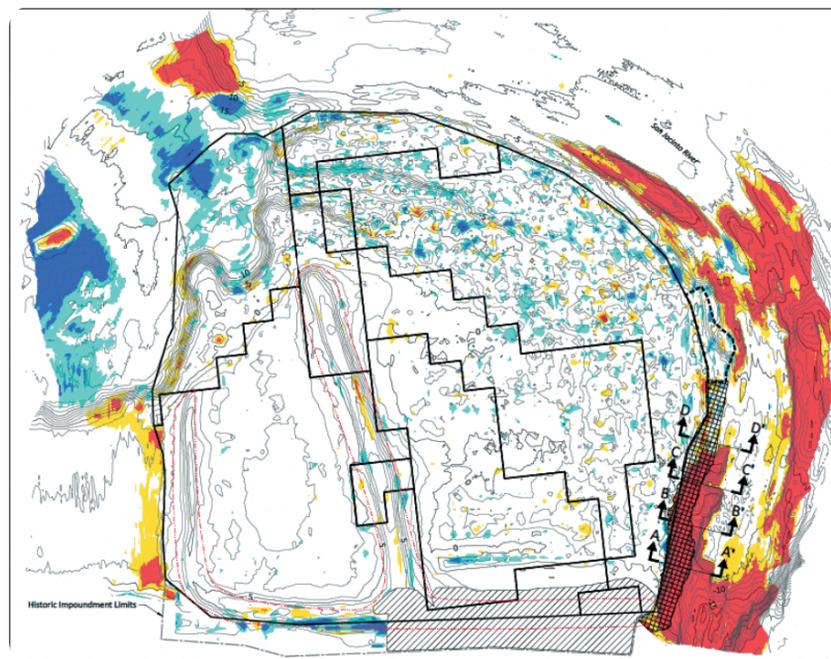
San Jacinto Riverbed scouring image post Hurricane Harvey. Gridded areas of riverbed labeled A, B, C, D will be repaired, as well as exposed toxin areas in Northwest corner (dark blue) See also Dr. Garland's report, on Page 2 overleaf.

Two areas of the site identified on this map caused particular concern to the EPA. The first of these is on the southeast side of the site, outside of the cap and waste pits, and appears in red on Figure 1. This area experienced significant erosion, and raised concerns that future events could erode into the waste pits on that side of the site. The EPA required a repair plan, and the PRPs installed additional rock armoring in this area to protect that side of the pits.

The second area of concern is on the northwest side of the site. This area has never been protected by a geotextile because the slope is too steep to allow rock armor to stay in place if there is a geotextile liner underneath it. Instead of geotextile, this area has an aggregate rock layer on top of the waste, and then rock armor on top of that. The aggregate rock layer is made of mixed sizes of gravel laid down in a thick sheet over the underlying waste. This layer is designed so that smaller pieces of gravel will fill in the spaces between larger pieces, creating a more cohesive and erosion resistant surface. Large rock armor is then placed on top of this mixed rock layer. The aggregate layer helps hold the larger rock armor in place. This area has undergone repairs in the past, as this construction is more easily damaged due to its composition and the steep slope in that area. EPA focused their dive team investigation and sampling on this part of the cap.

Based on the map and the probe survey, EPA calculated that damaged areas totaled 6700 square feet, distributed across the entire site. The probe survey confirms the conditions indicated by the site mapping: local currents and eddies thinned the rock armor, and in some areas scoured out the rock down to the underlying geotextile. Some of these scour features remain. In other areas, these scours were filled back up with new sediment. Elsewhere on the cap, the armor and geotextile remained in place and were buried under several inches to a few feet of new sediment.

DALLAS – (June 29, 2018) EPA is directing the potentially responsible parties of the San Jacinto River Waste Pits Superfund site in Texas to take immediate action to address damage to the protective cap. Initial repairs will begin shortly at the damaged areas where the protective rock was missing. Upon completion, EPA will inspect the final repair.

EPA has directed both International Paper and Industrial Maintenance Corporation, the potentially responsible parties (PRPs) for the San Jacinto Waste Pits Superfund site in Harris County, to take steps to ensure that the exposed waste material is isolated and securely covered. The dioxin in the waste material does not dissolve easily in
